RHS, Inc
PO Box 5159
Laytonsville, MD 20882

1234 Any Dr
Anywhere, MD 20000

General Information

Client Name: John Doe
Property Address: 1234 Any Dr
City: Anywhere State: MD Zip: 20000
Agent/Contact Name: Buyer's Agent

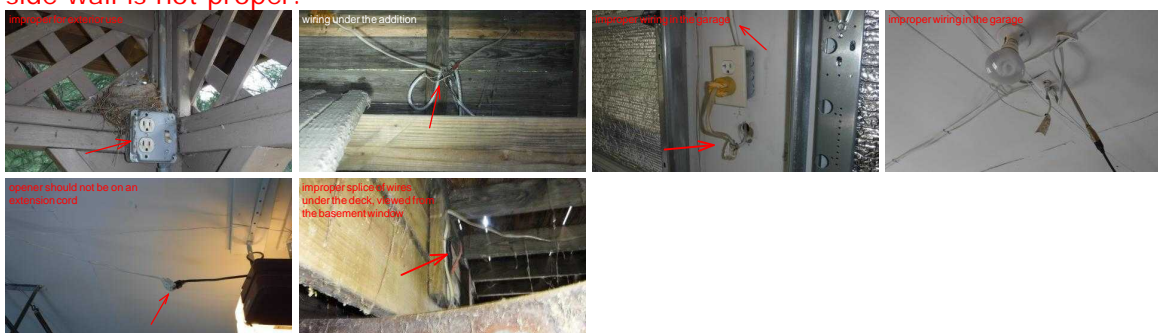
- Misc. Electric: The wiring is not proper for exterior work to the gazebo. Examples - not exterior rated electrical box, switch and not GFI protected outlet. The wiring under the addition is not safe. There is an open splice of wires and two strands of wires not protected by the sheathing. The rear left bedroom does not have a switched outlet or light. The wiring in the garage is not proper or safe. Examples - openers into extension cord, wires run improperly along the walls and ceiling and outlets are not GFI protected. There is a tapped wire connection under the deck which was viewed from the rear basement window. The wiring in the utility room behind the side wall is not proper.

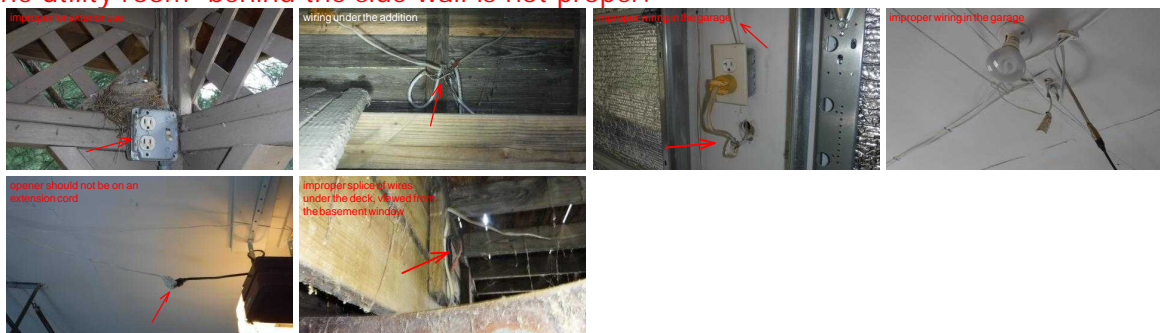
26. Misc. Electric: The wiring is not proper for exterior work to the gazebo. Examples - not exterior rated electrical box, switch and not GFI protected outlet. The wiring under the addition is not safe. There is an open splice of wires and two strands of wires not protected by the sheathing. The rear left bedroom does not have a switched outlet or light. The wiring in the garage is not proper or safe. Examples - openers into extension cord, wires run improperly along the walls and ceiling and outlets are not GFI protected. There is a tapped wire connection under the deck which was viewed from the rear basement window. The wiring in the utility room behind the side wall is not proper.

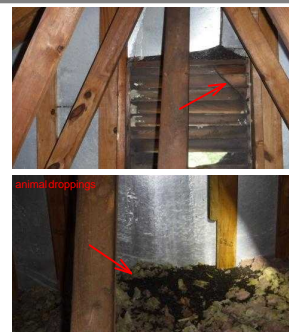
28. Attic Ventilation: The front gable screen is damaged. There is a pile of animal droppings that appear to be from bats. Need to have the droppings removed and the screen replaced. Droppings can cause illnesses.
29. Attic Additional observations: The attic access is not the proper material. It should not be a thin piece of wood. Need a contractor to replace it.
